Inventory Number: VA 14720

## PHASE I INSPECTION REPORT

⑥  
Brisentine's Dam (Inventory Number VA 14720)  
James River Basin, Prince Edward  
County,  
Commonwealth of  
Virginia.

September 1980

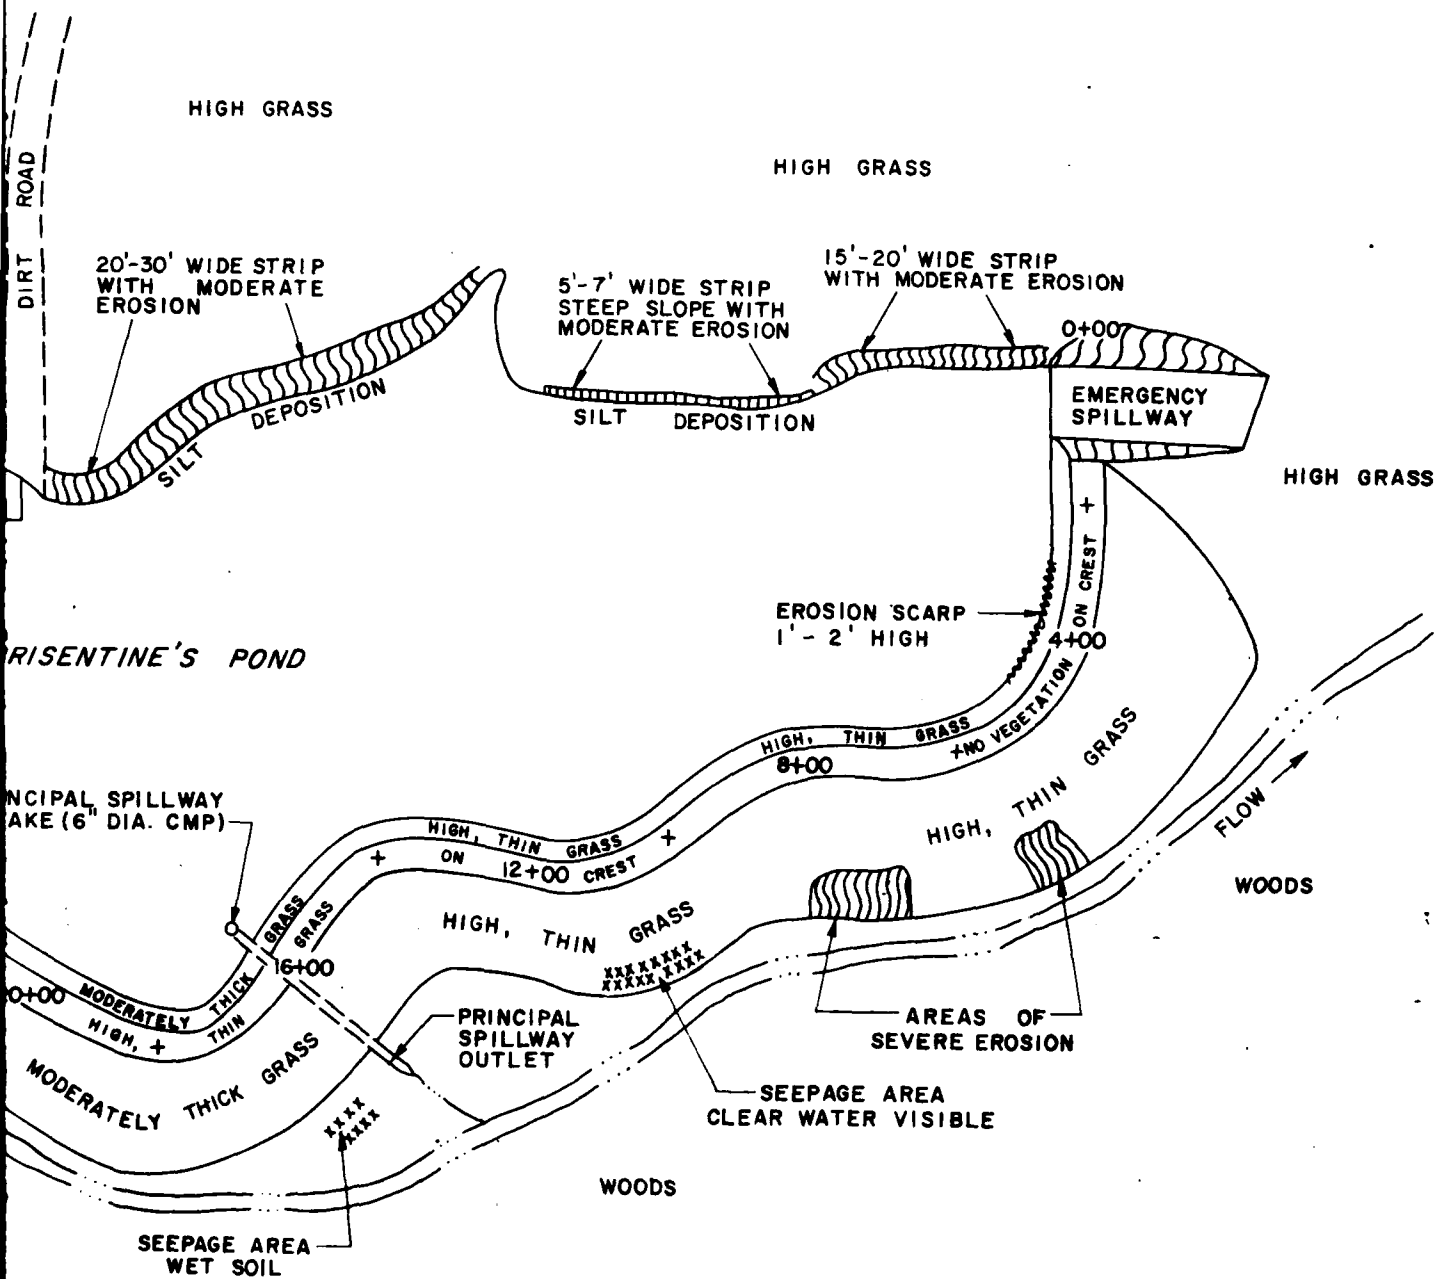
PLATE 1

Due to the length and irregular shape of this dam, the locations of all deficiencies found during the field inspection are referenced to the stationing established during the inspection for the "top of dam profile" survey. This stationing is shown on the Field Sketch, Plate 1 of this report.
